Golden Pass Compressor Failure

Introduction

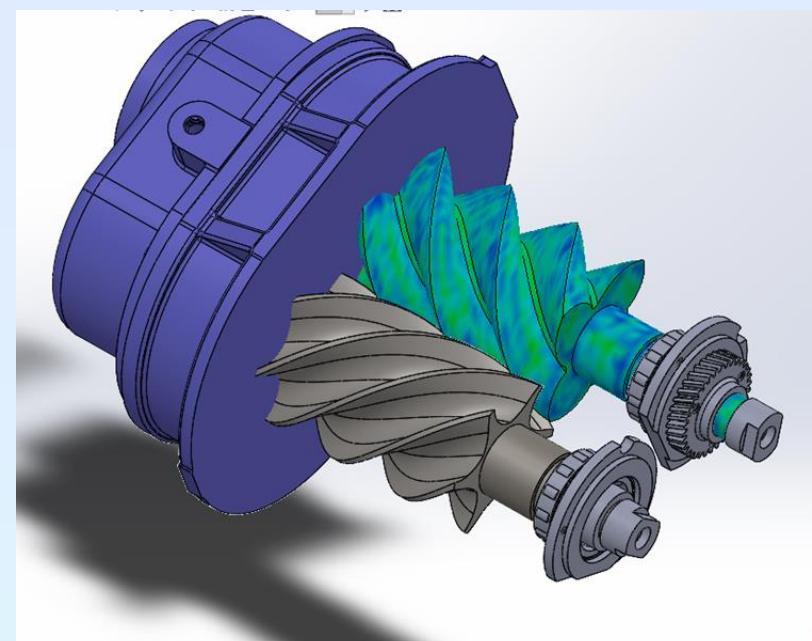
Figure 2: Rotor Simulation

A stress simulation was run on the compressor rotor models to determine the von Mises stress. The von Mises stress concentration in the simulation is lower than the hand calculation since it doesn't take surface contact into consideration. According to the simulation, the von Mises stress is 99.9 psi.

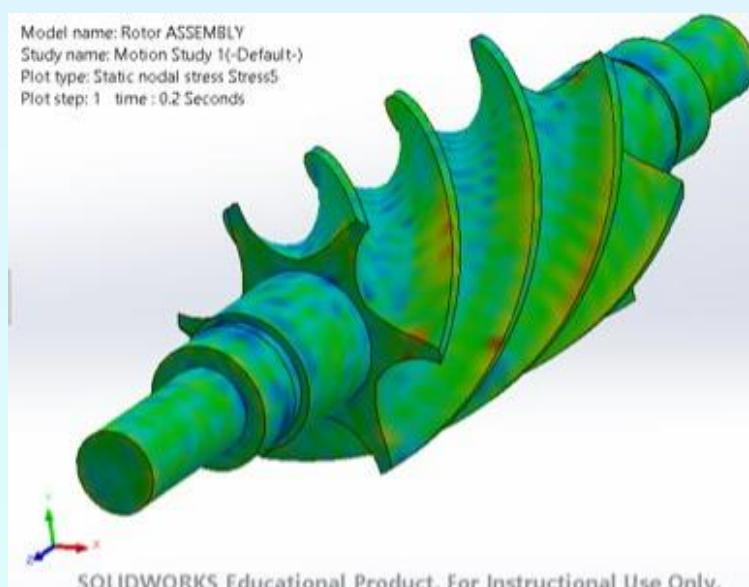
Figure 3: Rotor Simulation Close-Up

In addition to the simulation not accounting for surface contact, the dimensions compared to the actual compressor are different. The team had to use calipers and tape measures in order to model the parts, which will cause some error. The way the compressor is manufactured is also supposed to minimize stress.

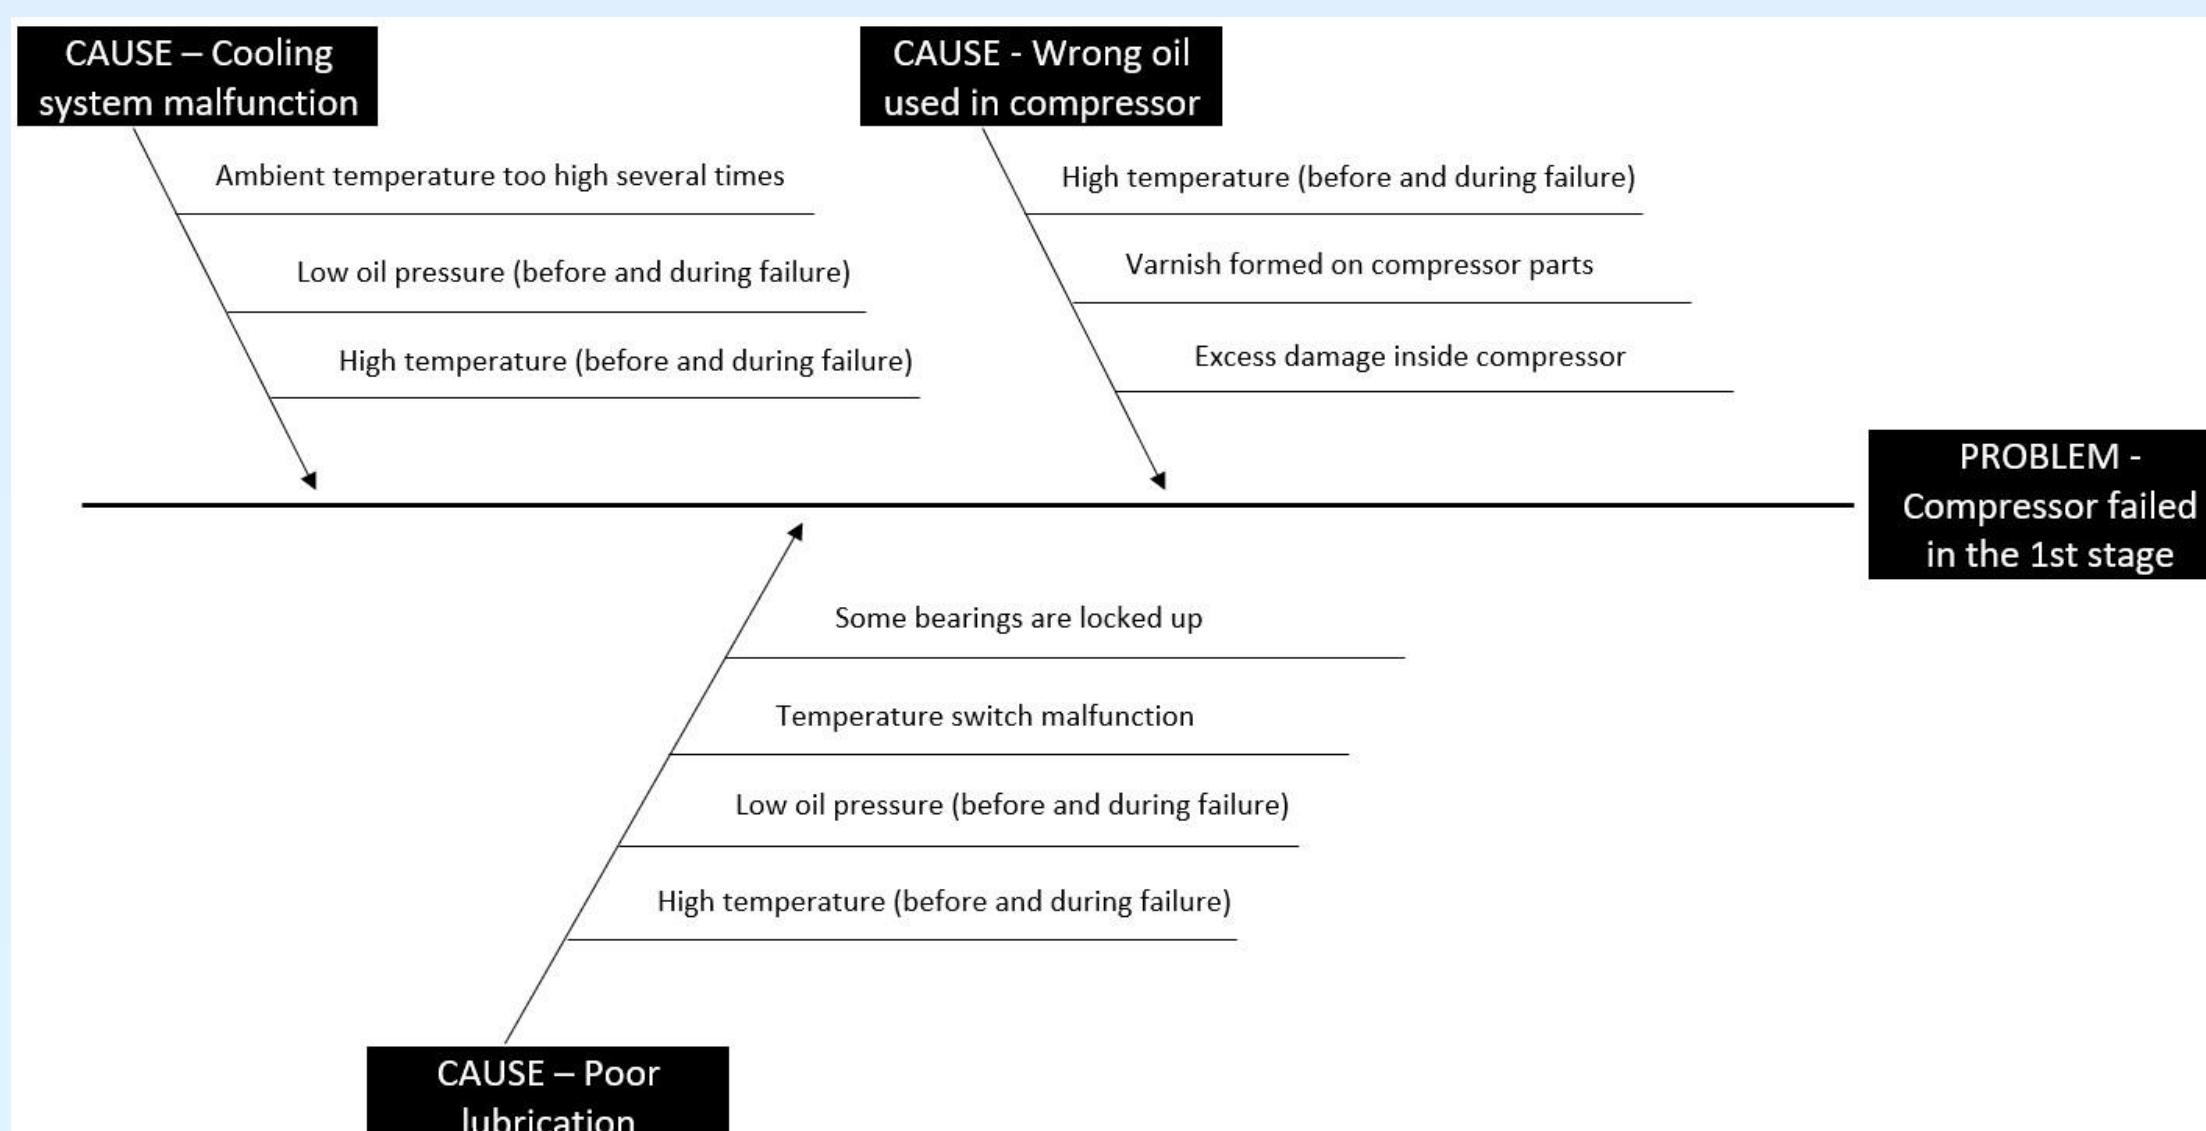
Figure 4: Root Cause Diagram

The team was able to complete all the objectives of the project. The main goal was to determine what caused the compressor to fail. Three possible causes were theorized, but the most reasonable one is poor lubrication since there is more evidence to support it. In addition, the team was able to see the heat damage and annealed Teflon on the rotors through SEM imaging.

After inspecting the physical compressor and looking over the operational data, the following root cause diagram was created. The diagram contains only possible causes, but the team can't know for sure what the actual problem was.

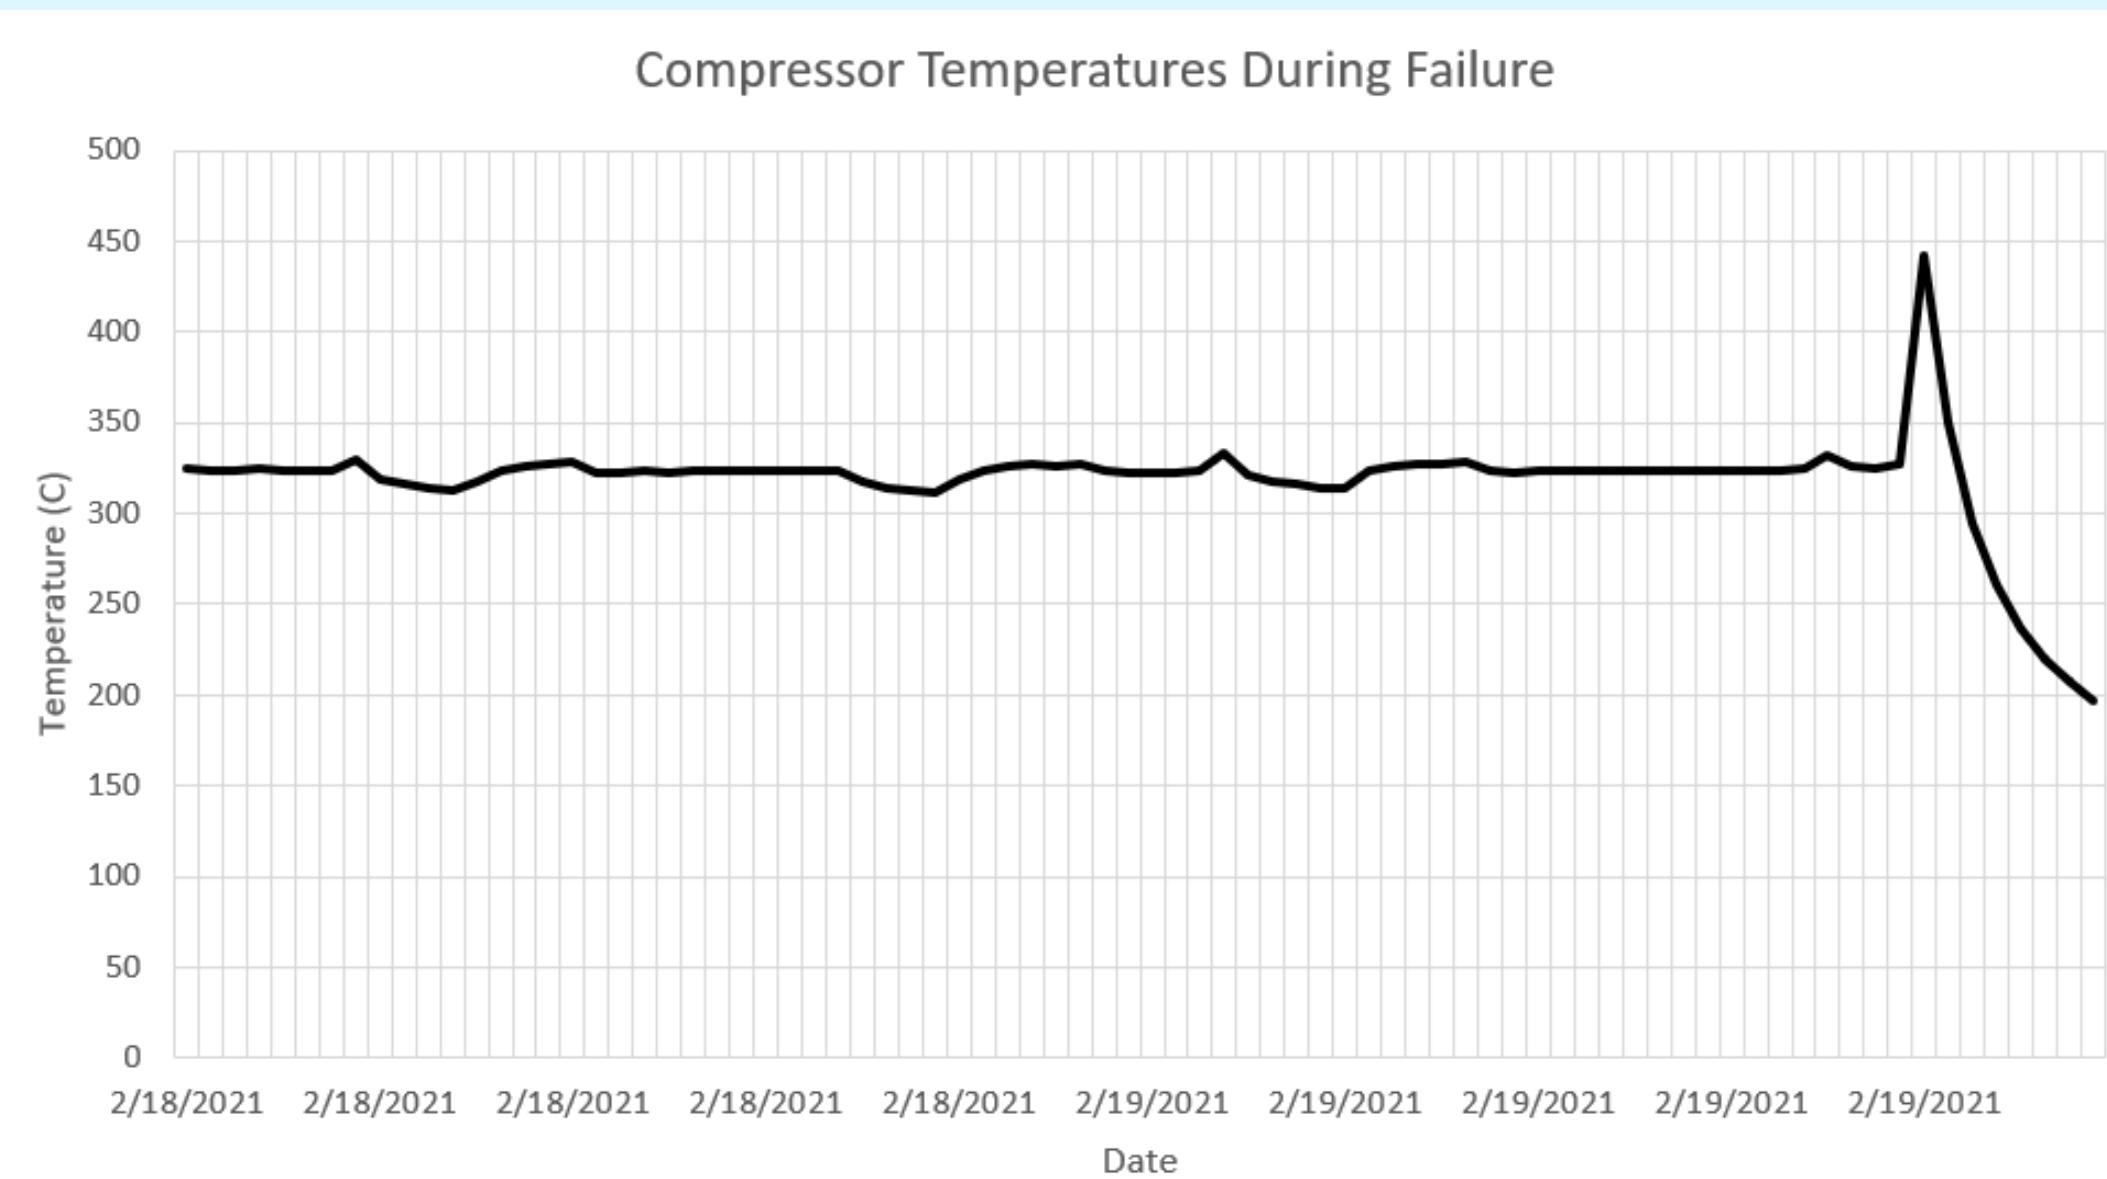
Figure 5: Compressor Temperatures

For the industrial side of the project, the data from January was compared to the data from February to determine if there were any comparisons to be made. They found out that the compressor was running above the shutdown level temperature (310° C) during the month of January. Then in February the temperature spiked at 442.3° C and the compressor failed.

Figure 5 shows the elevated temperatures the compressor experienced during the failure on February 19th, and right before that on the 18th. The temperature level corroborates the damage to the internal parts and aided in determining the cause of failure. In addition to the other issues, the temperature switch not working leads the team to believe that the cause of failure is likely poor lubrication.
